# Inspection Report

**John & Kimberly Doe  
31 Carlisle Street  
Andover, MA 01810**

## **ABBEY Home Inspection**

Report Date: **10/17/2017**

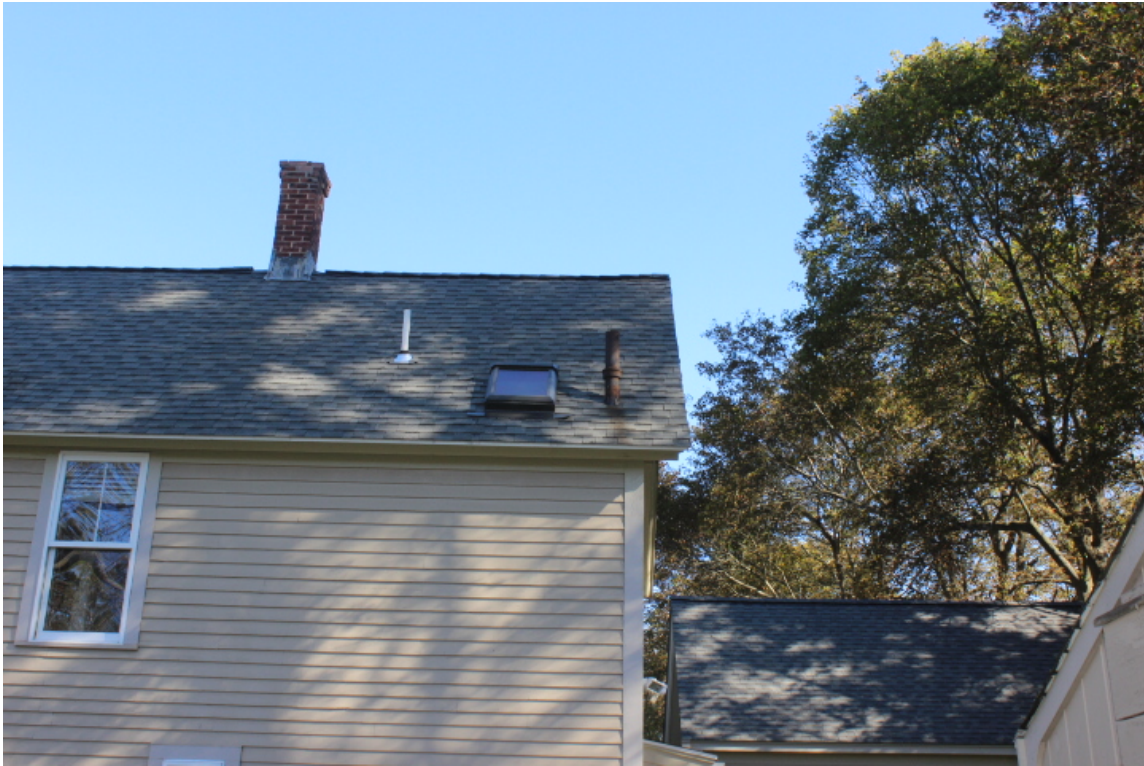
**# R1**

19 **Brick crown is in fair condition and may need upkeep in the near future.**

**Roof  
Roof and chimney**

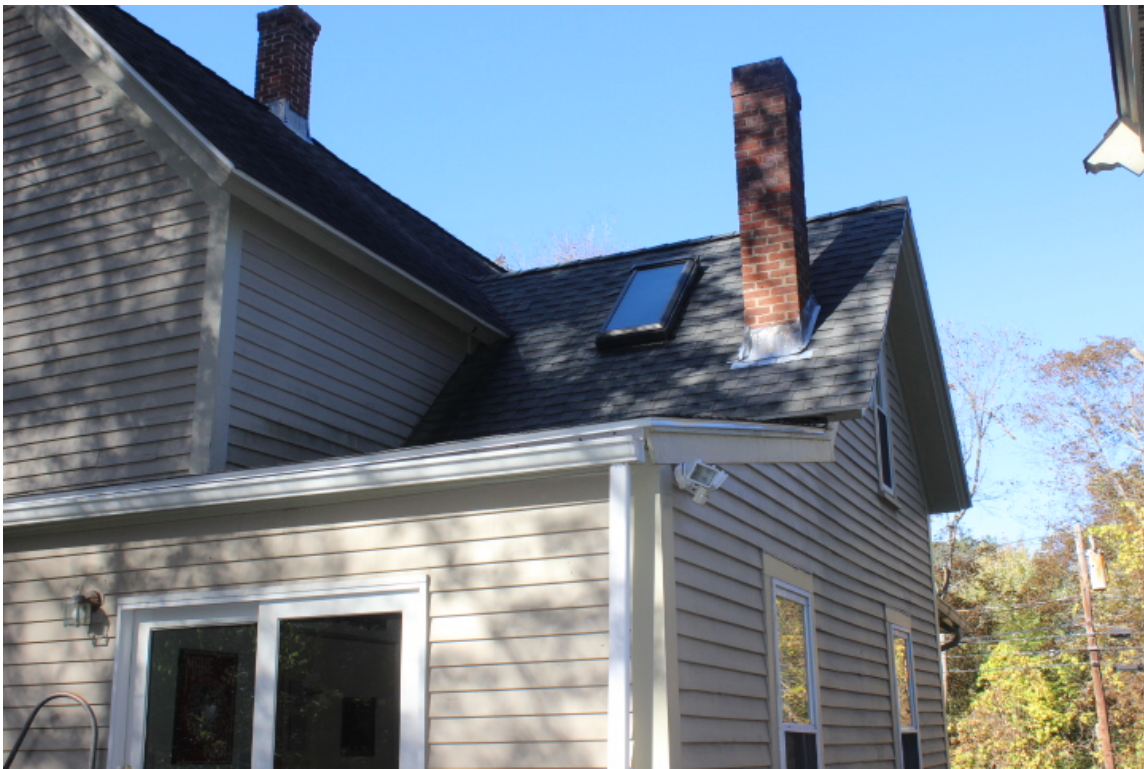
**# R2**

**Roof  
Roof & Chimneys**

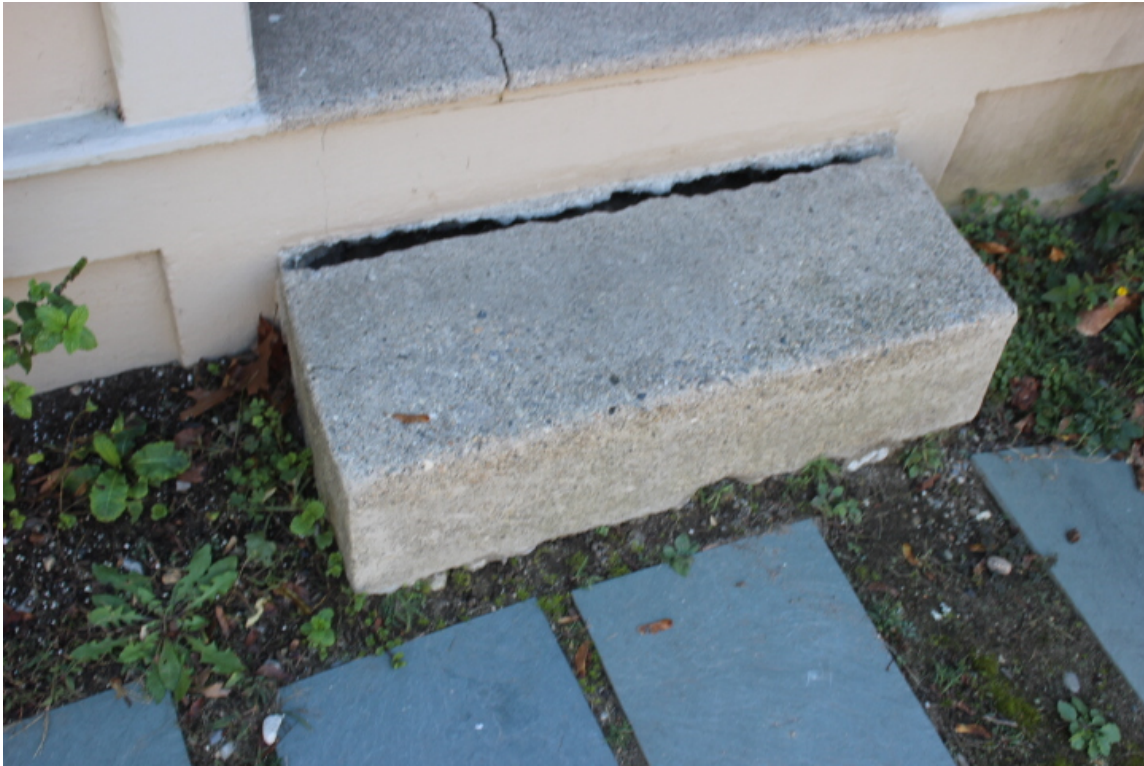
**# EX1**

**16 Entry steps are not uniform (riser heights are different and tripping is possible).**

**Step is not uniform (trip hazard noted)**

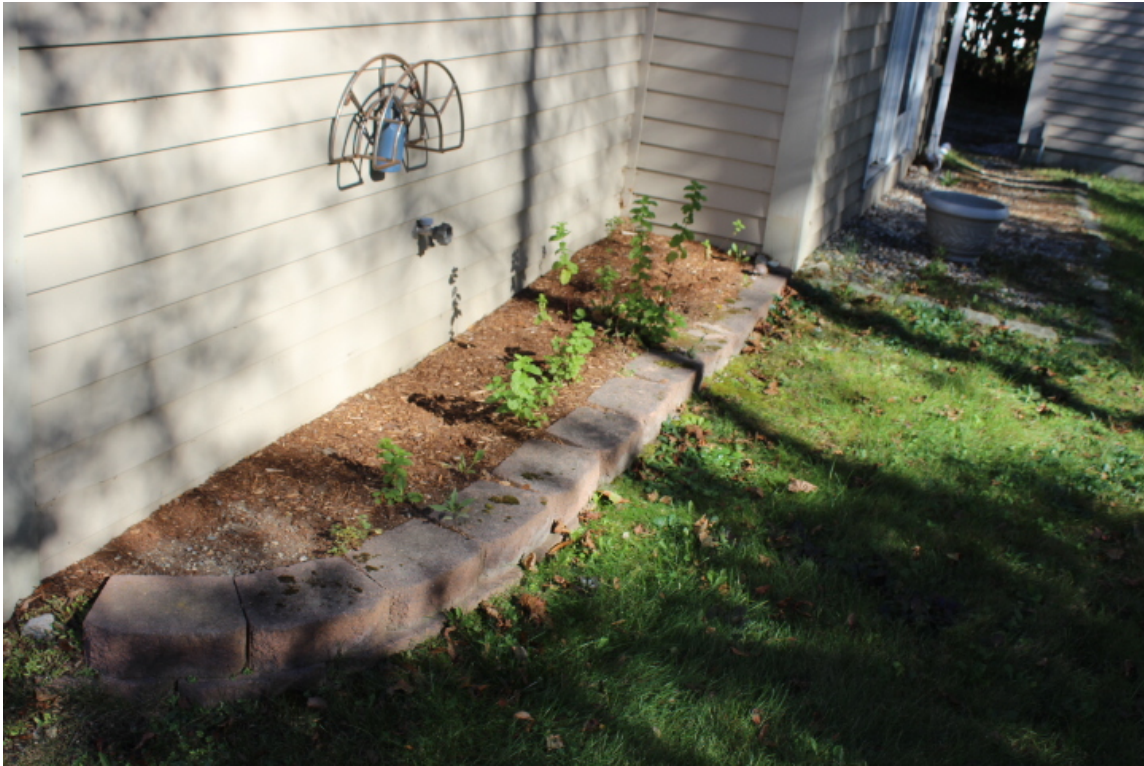
**# 1**

Drainage conditions are marginal at building perimeter. Recommend landscape improvements including soil removal from exterior wall. Also, pitch soil for proper drainage and improve run off (slope soil away from foundation walls)\*. See Addendum Page.

**Grounds & Drainage**  
**Soil elevated at wall sill (cause for concern)**

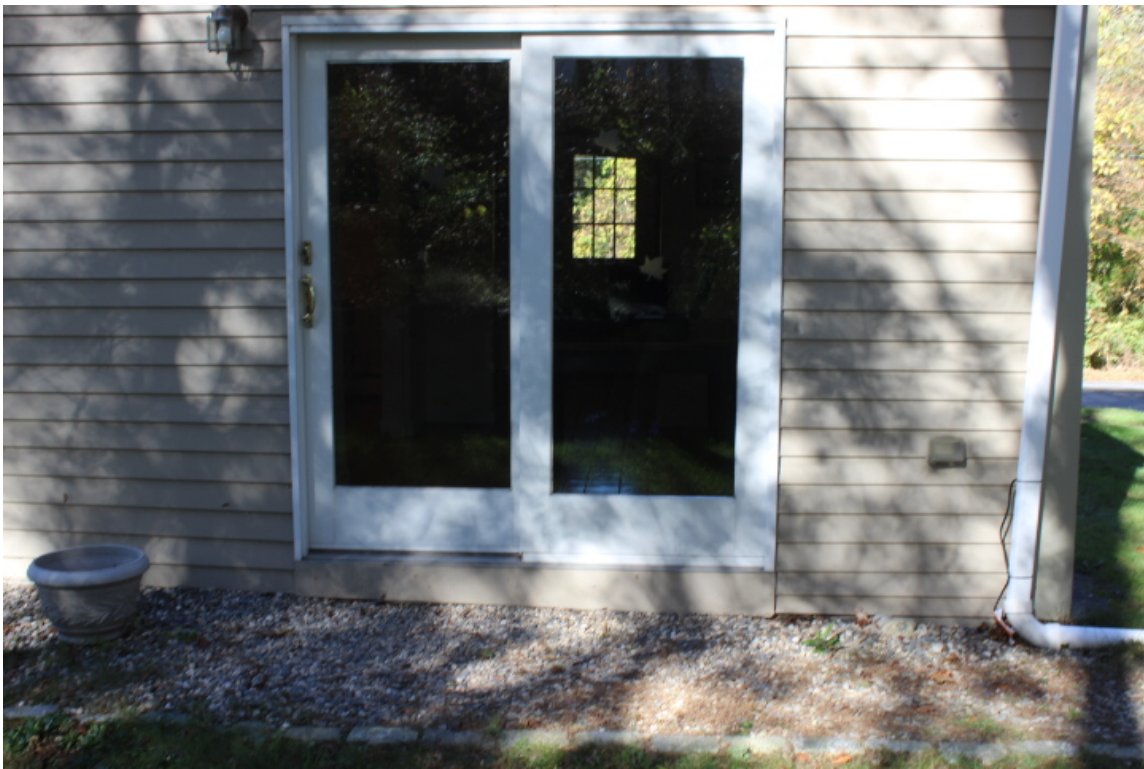
**# 2**

\*Soil contact against building may allow insects and moisture damage. Hidden or concealed damage is not evaluated at this time. Check area behind siding once soil is removed. Addressing this conditions prior to transfer is preferred.

**Grounds & Drainage**  
**Soil contacts wood siding (insect or decay is possible)**

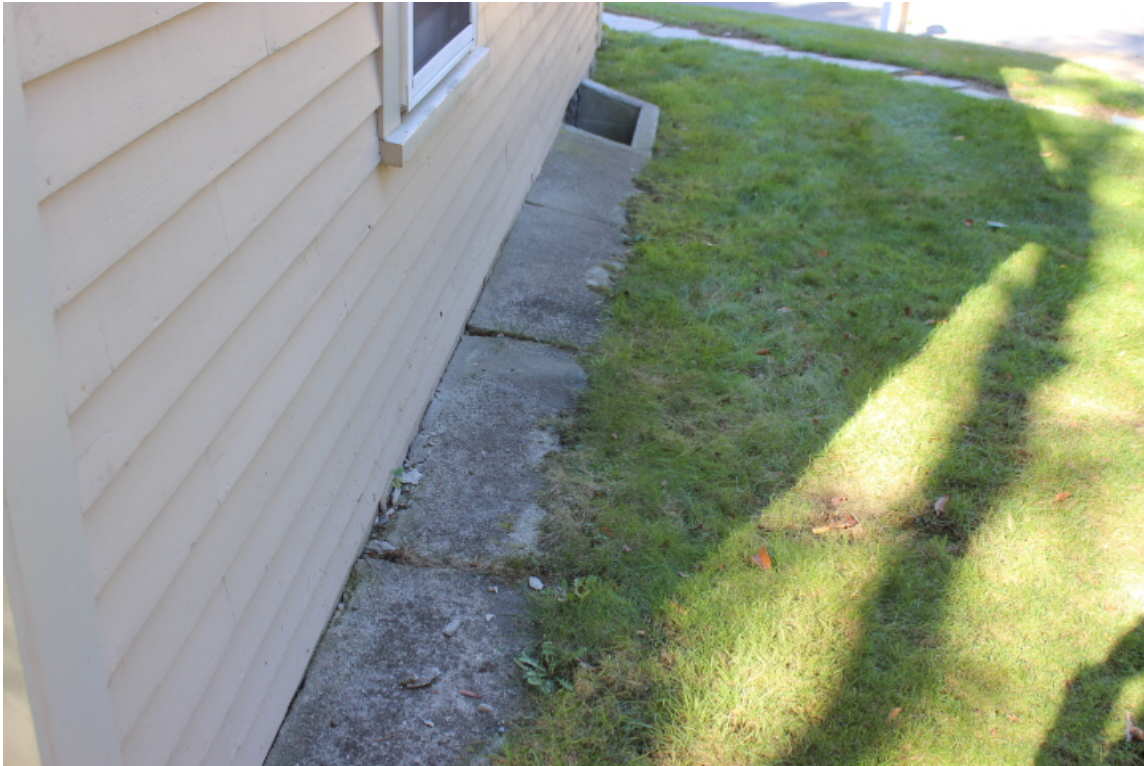
**# 3**

**Grounds & Drainage**  
**Soil elevated against house (wood surface)**

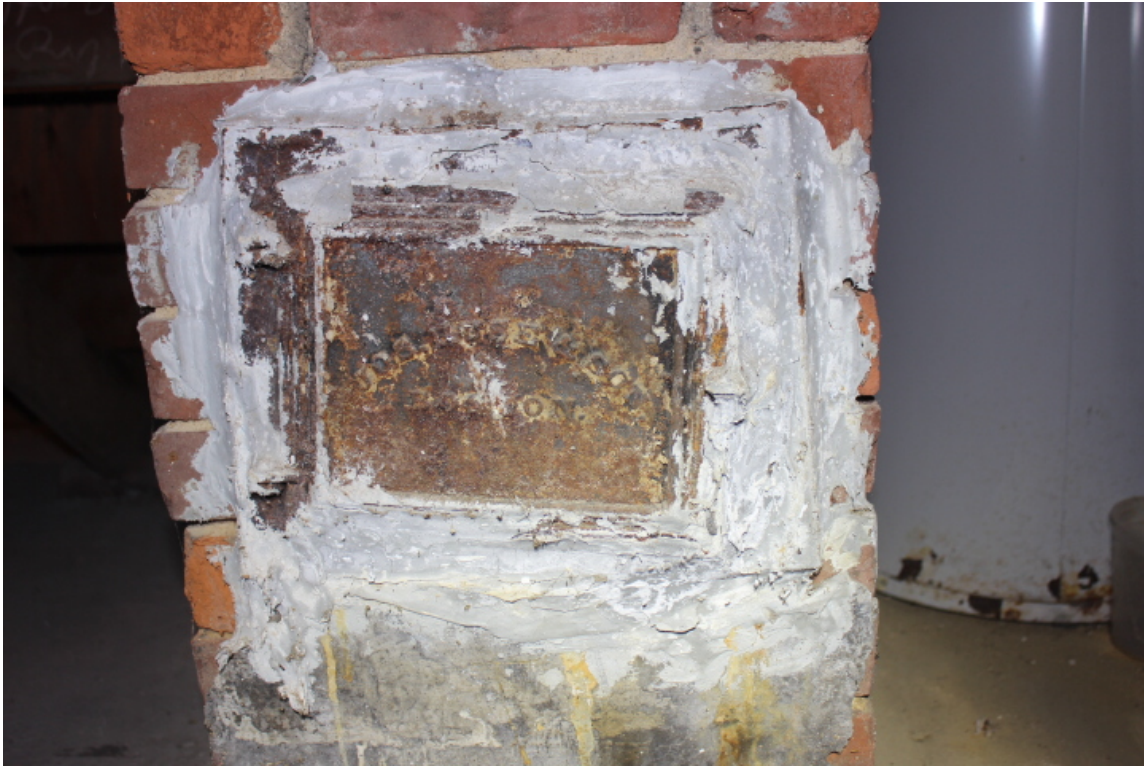
**# HC1**

24 Exhaust pipe and flue need to be secured to chimney. Chimney has no clean-out and would need to be used for an annual inspection of chimney. Clean-out cover at chimney is not operational and needs improvement.

**Cleanout cover is sealed shut**

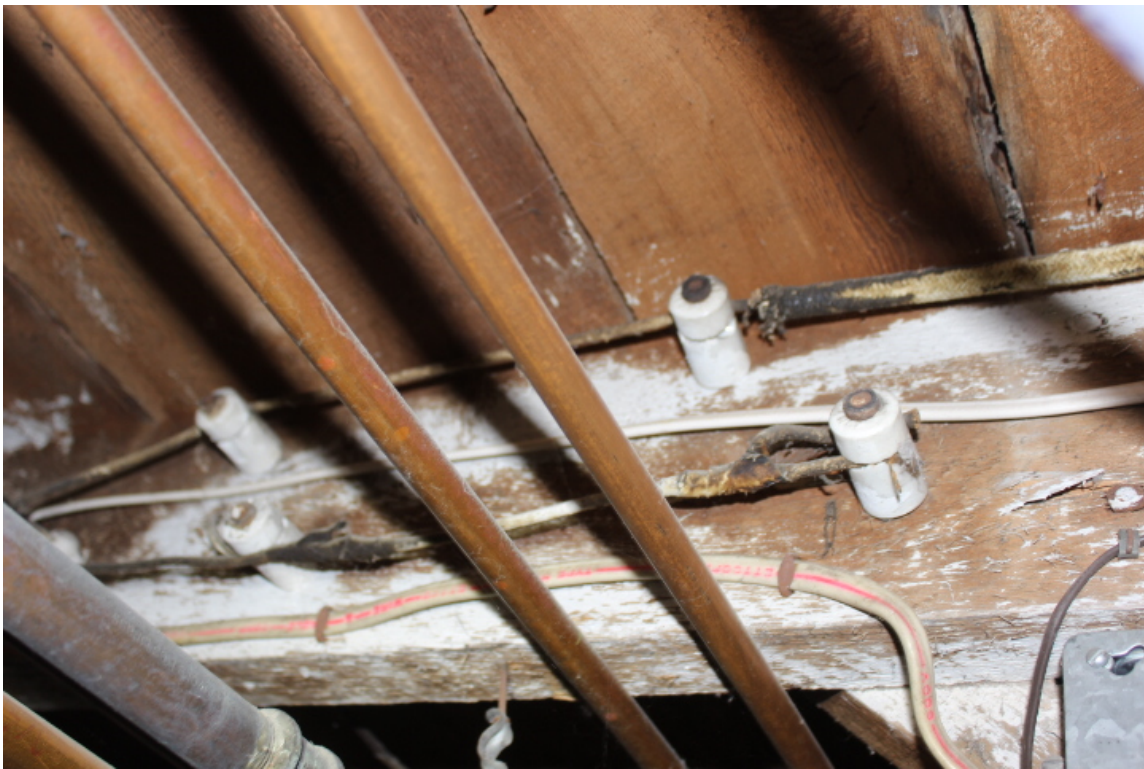
**# EL2**

19 Old knob and tube is present but appears disconnected.

**Electrical**  
**Terminated wires (knob and tube)**

Removing abandoned wiring is suggested (dated knob and tube cable is visible).

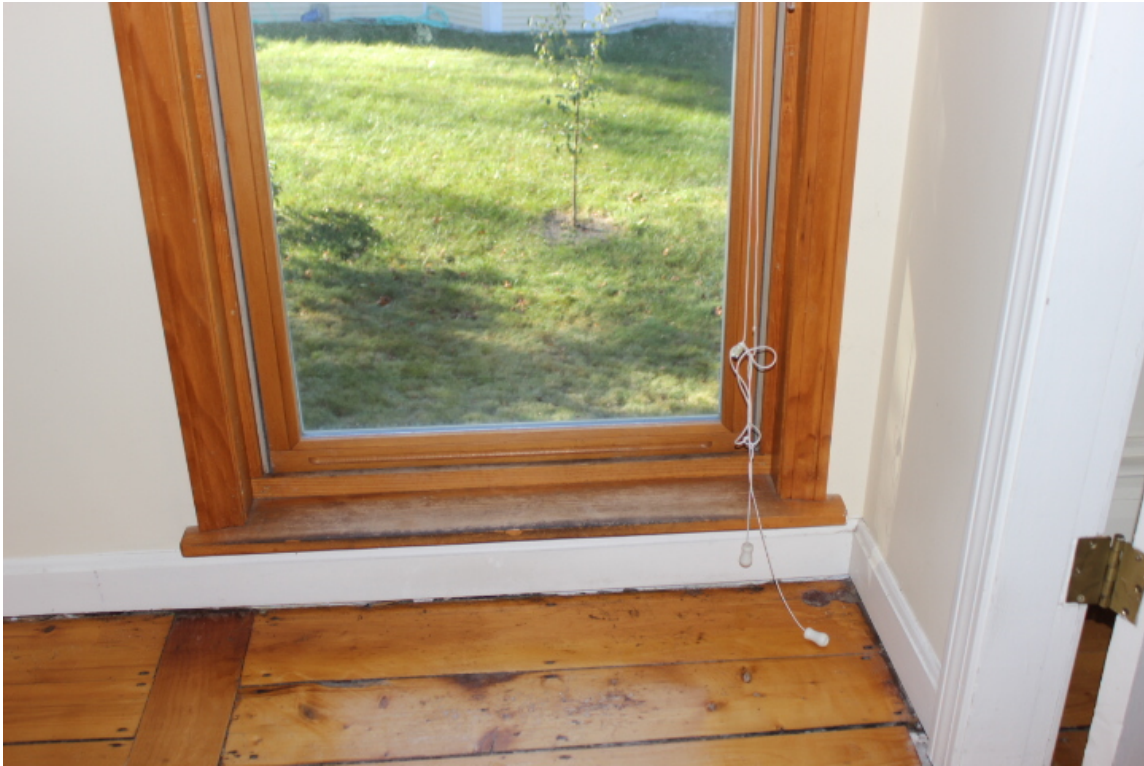
**# 1**

- 17 **Repair window as necessary at second floor hallway. This window is low to floor and should have tempered glass for added protection. Add grill and or bars to avoid injuries to children.**
- We do not evaluate smoke detectors or monoxide alarms. Local regulations require certification prior to transfer. Seller is required to schedule certification.**
- Adjust and secure lock at slider as needed.**

**Loose sash with no tempered glass (very close to floor)**

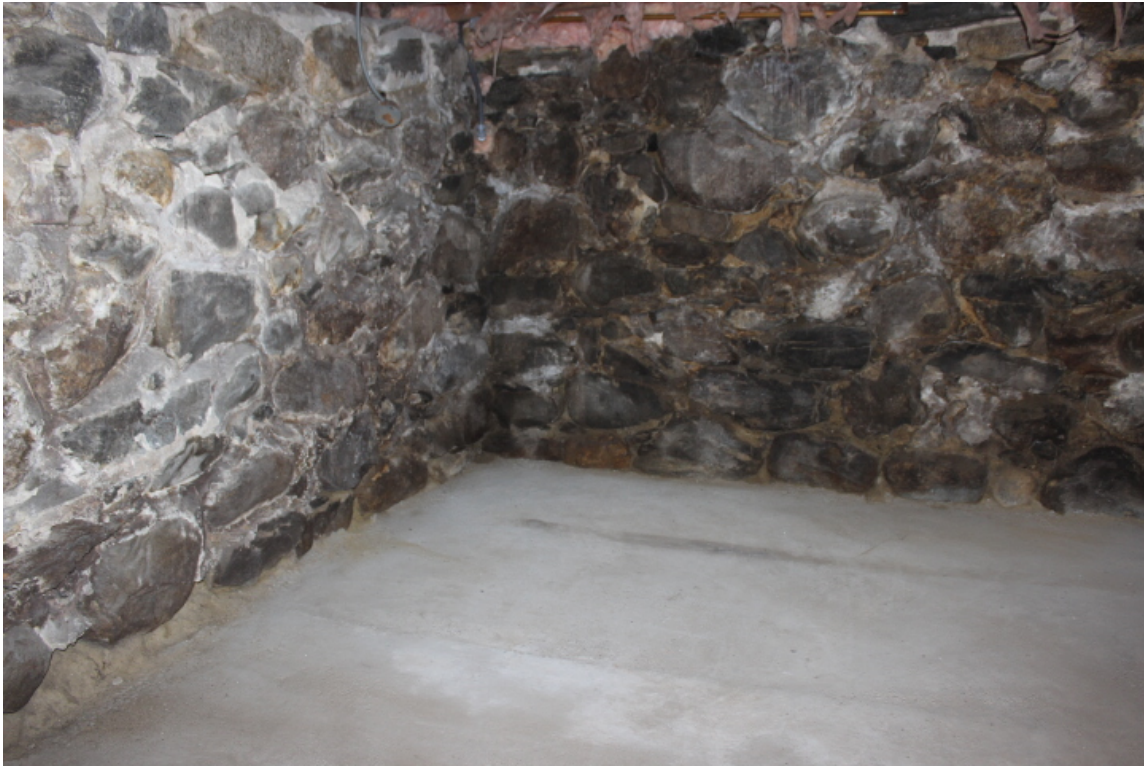
**# F1**

18 Concern for dampness and seepage\* is noted along basement wall (rear wall). No water is present at time of inspection however, we'd suggest water proofing be applied at outer wall by an expert in this field. Also, drainage improvements at exterior are indicated elsewhere in this report including Grounds Page. See Addendum Page for additional water control comments.

**Foundation  
Dampness at rear wall**

\*Request history of water seepage into basement. Owner can verify amounts and frequency while living in the home. Additionally, sump pump is warranted for added precaution.

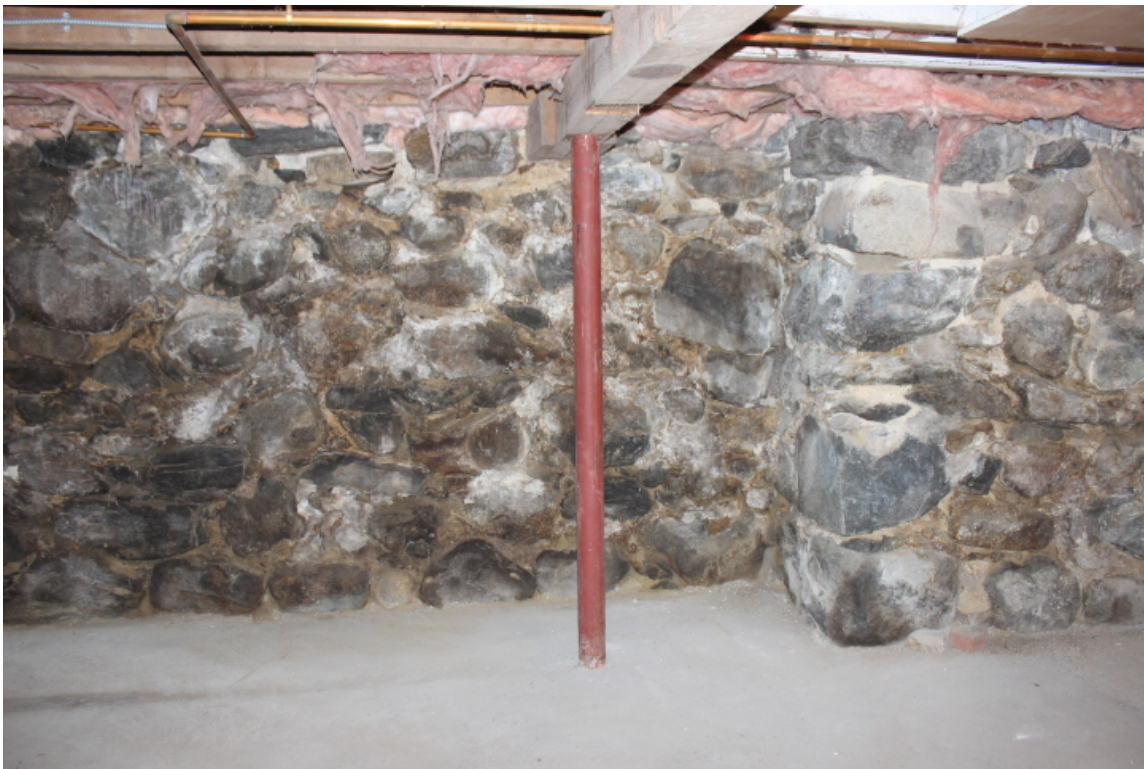
**# F2**

**Foundation  
Wall dampness (rear)**

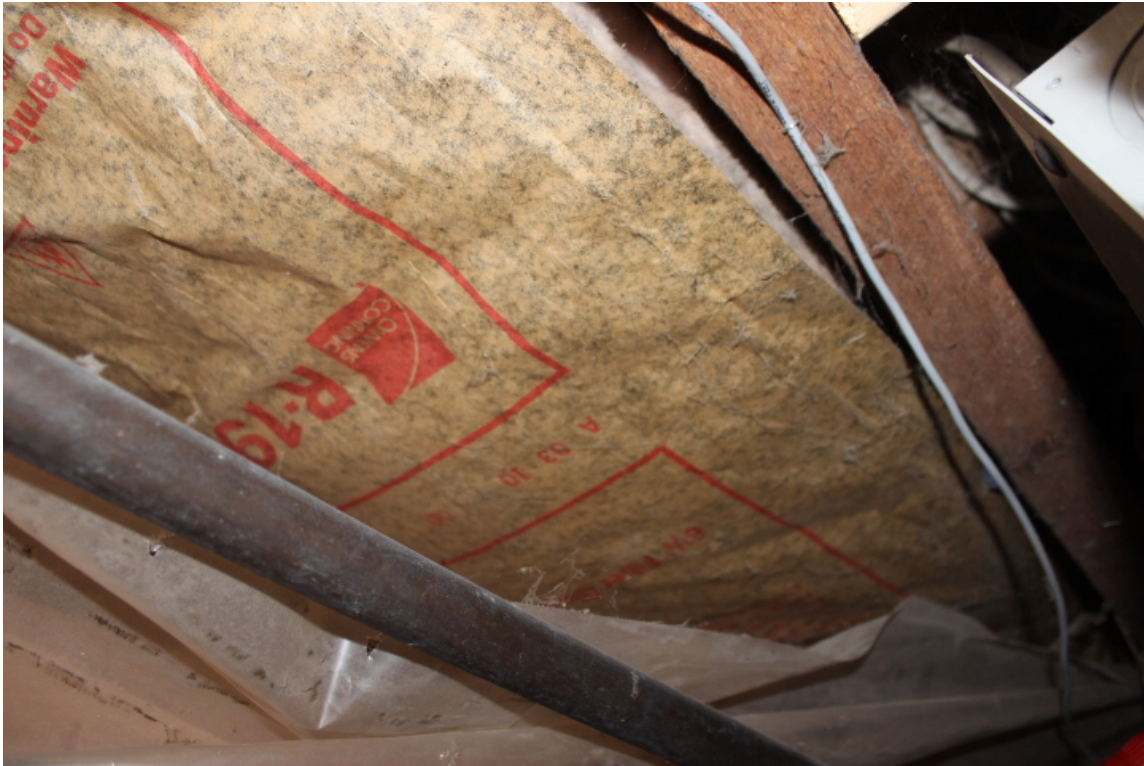
**# F3**

Kraft paper is exposed at ceiling above laundry area. Warning label by the mfg'r recommends covering insulation with proper gypsum or sheet rock (not polyethylene).

**Foundation  
Kraft paper (insulation)**
